KC750 TO KW11-K

TECHNICAL INFORMATION

EP-KC750-TI-AE
1 OF 1 APR 1988
COPYRIGHT© 1988

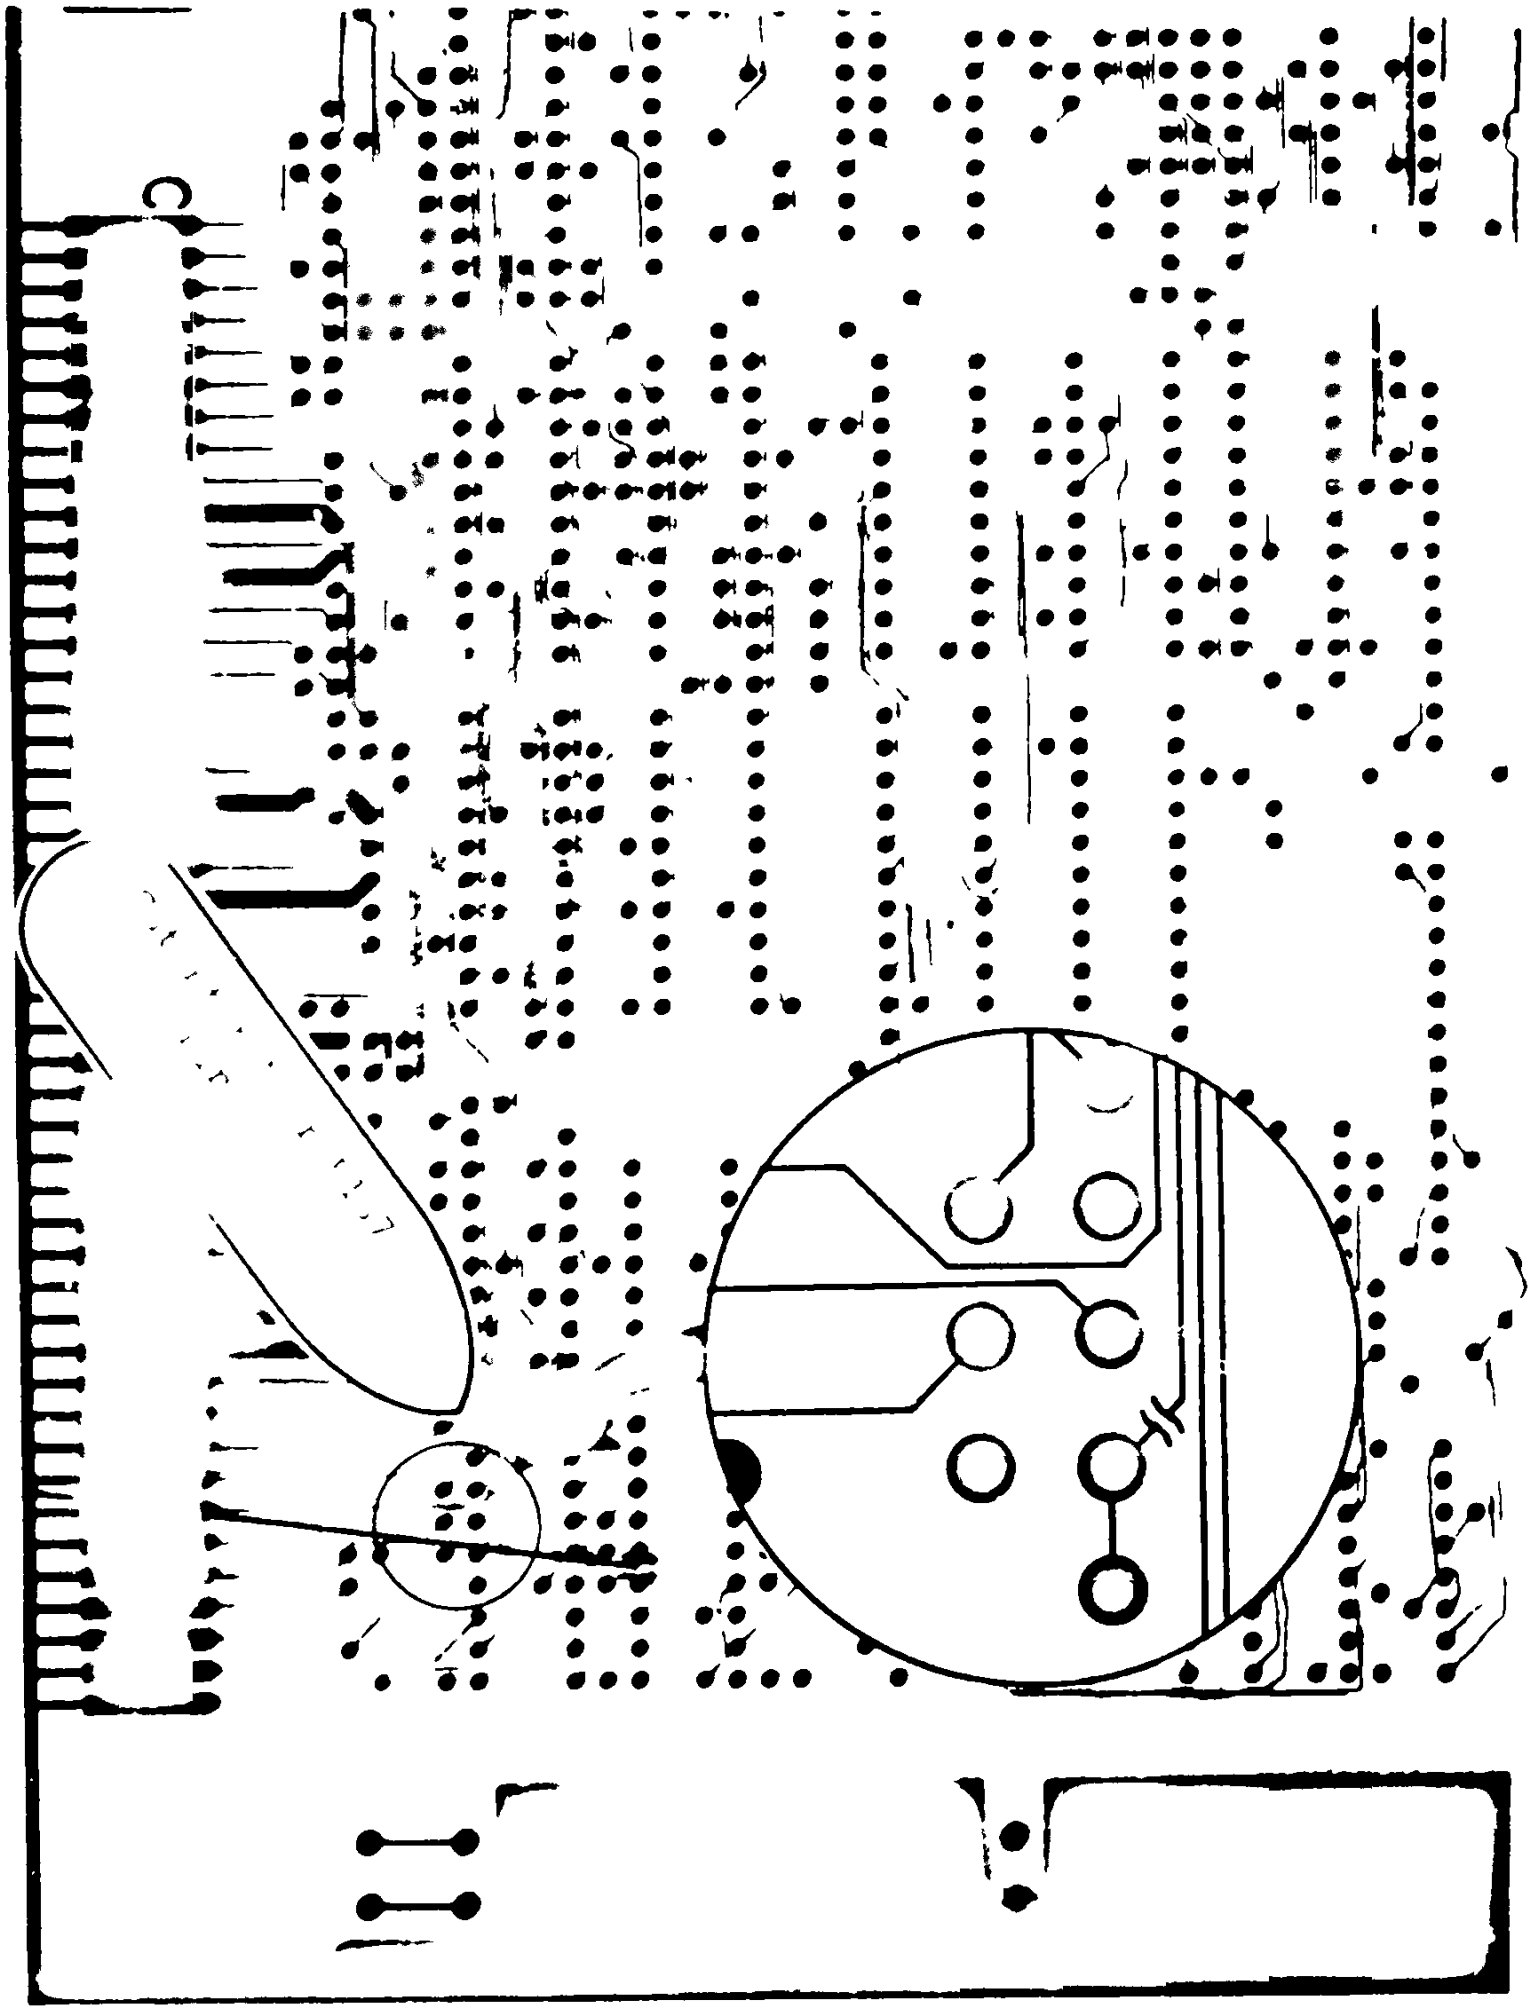
Figure 1

SEPT 83 - PROBLEM The KC750 option is not secure when the keyswitch is in the Remote/Secure position Th s can allow the memory of a running system to be mod fied from the remote port even if the keyswitch is in the Remote/Secure position

5. Cut etch, side 2, between E176 pin 24 and E187 pin 5 near E187 pin 5 (Figure 1).

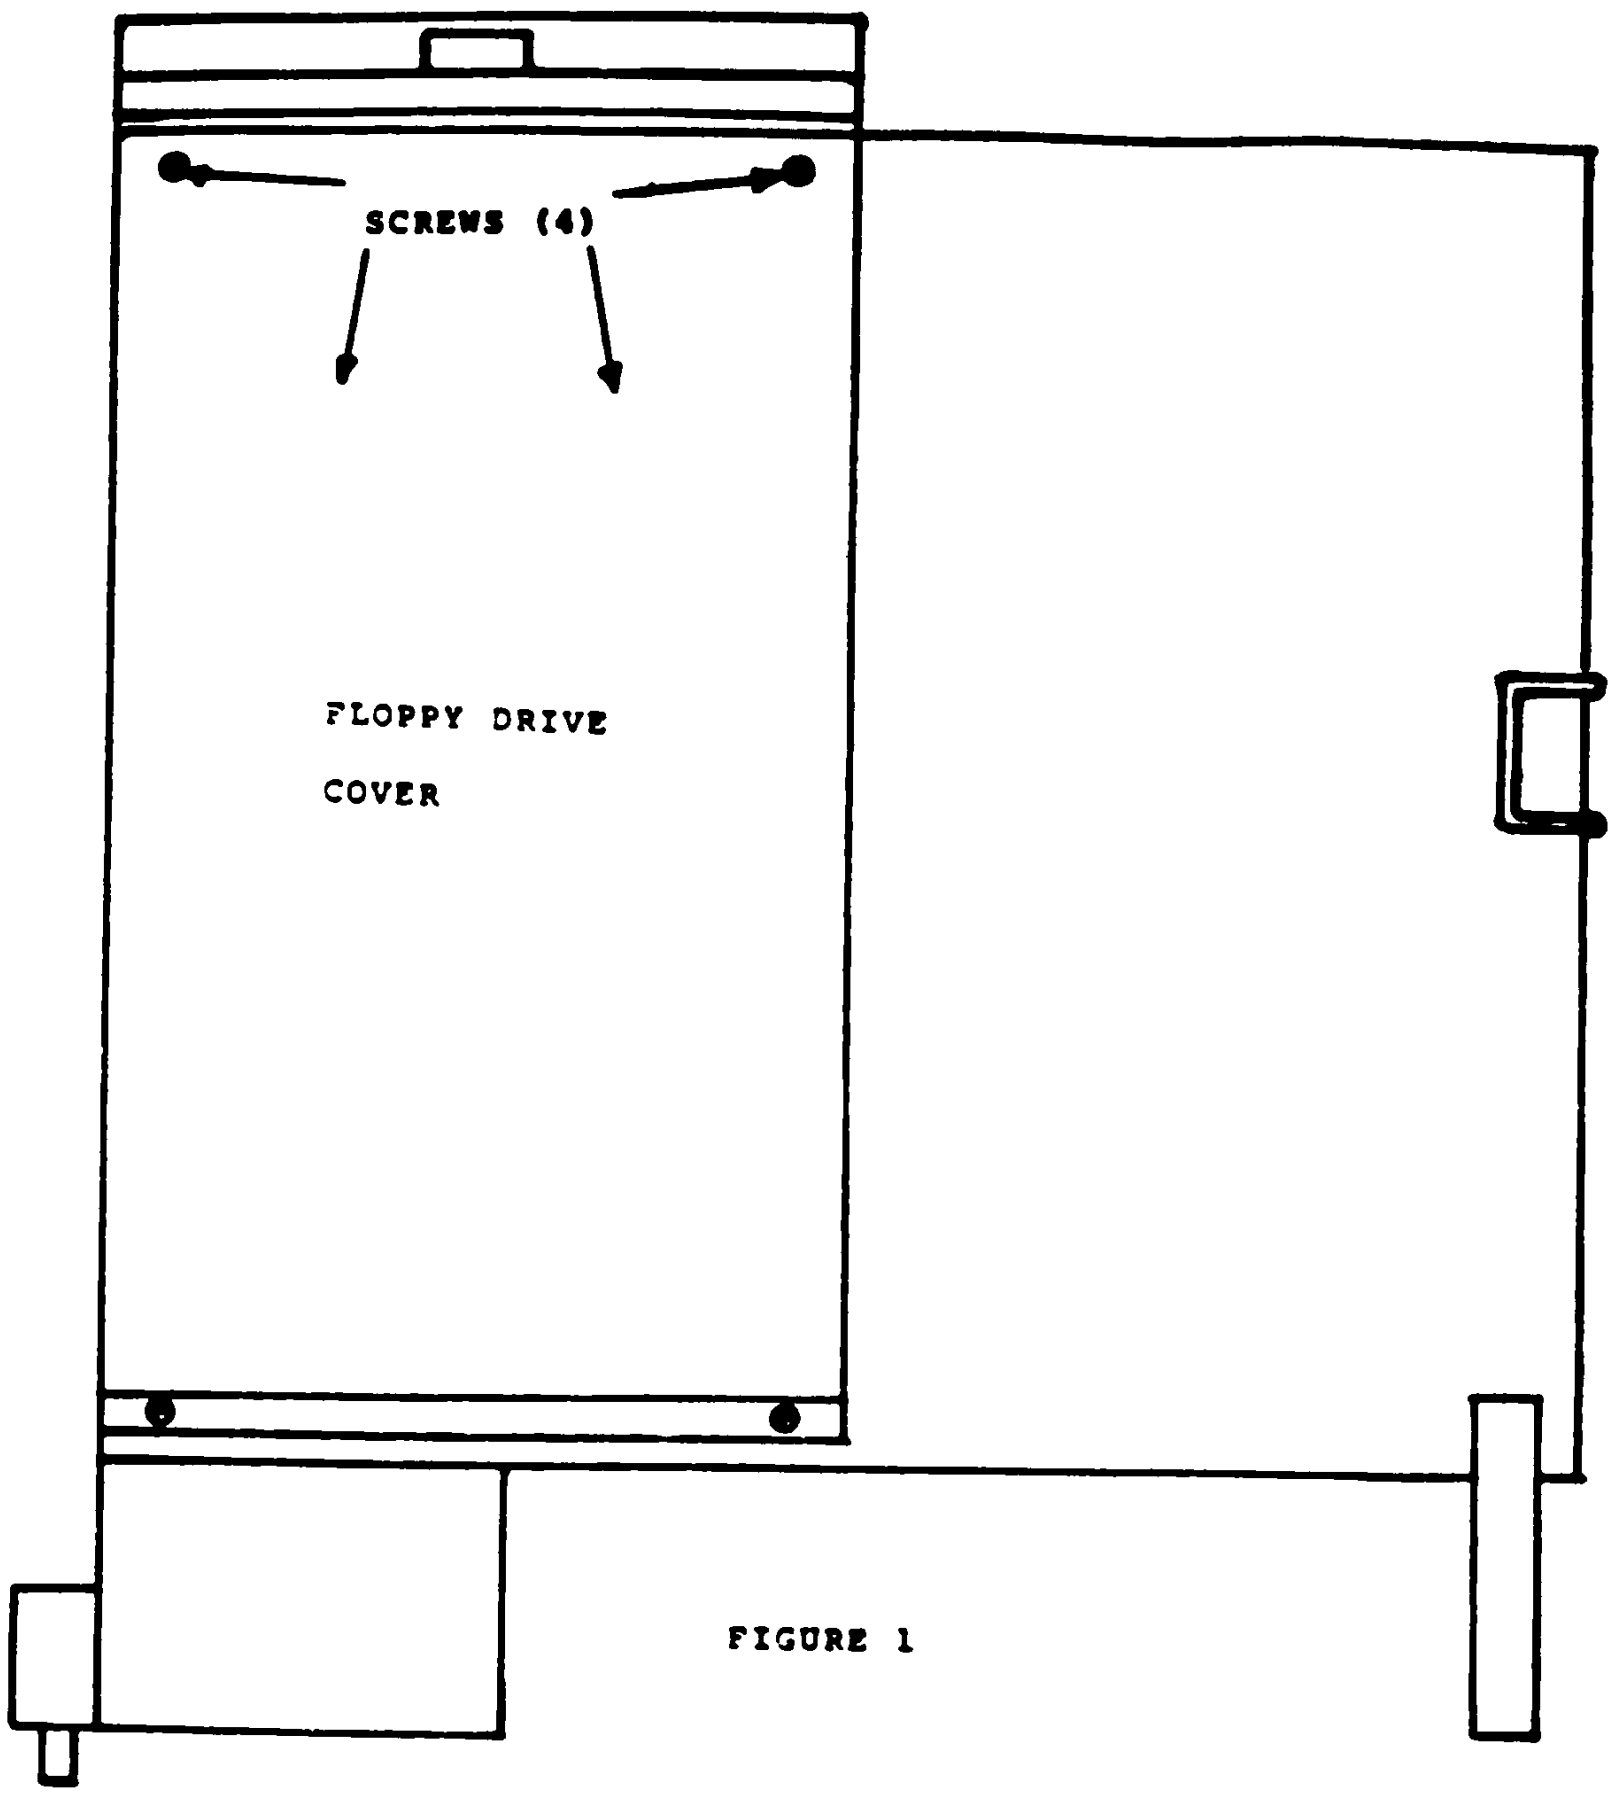
FIGURE 1

Problem/Symptom: The Floppy Drive Motor AC wires are too loose and can come into contact with the blades of the Muffin Fan Assembly. This results in cutting the wire and shorting the wires to the fan hub and chassis.

5. Carefully inspect the two (2) black drive motor wires to assure that the insulation has not been damaged by contact with the moving elements of the Muffin Fan. (If insulation has been damaged, repair the wire by using the shrink tubing (91-07305-09).

4. Remove cover from floppy drive (figure 1). The cover is held in place by four screws.

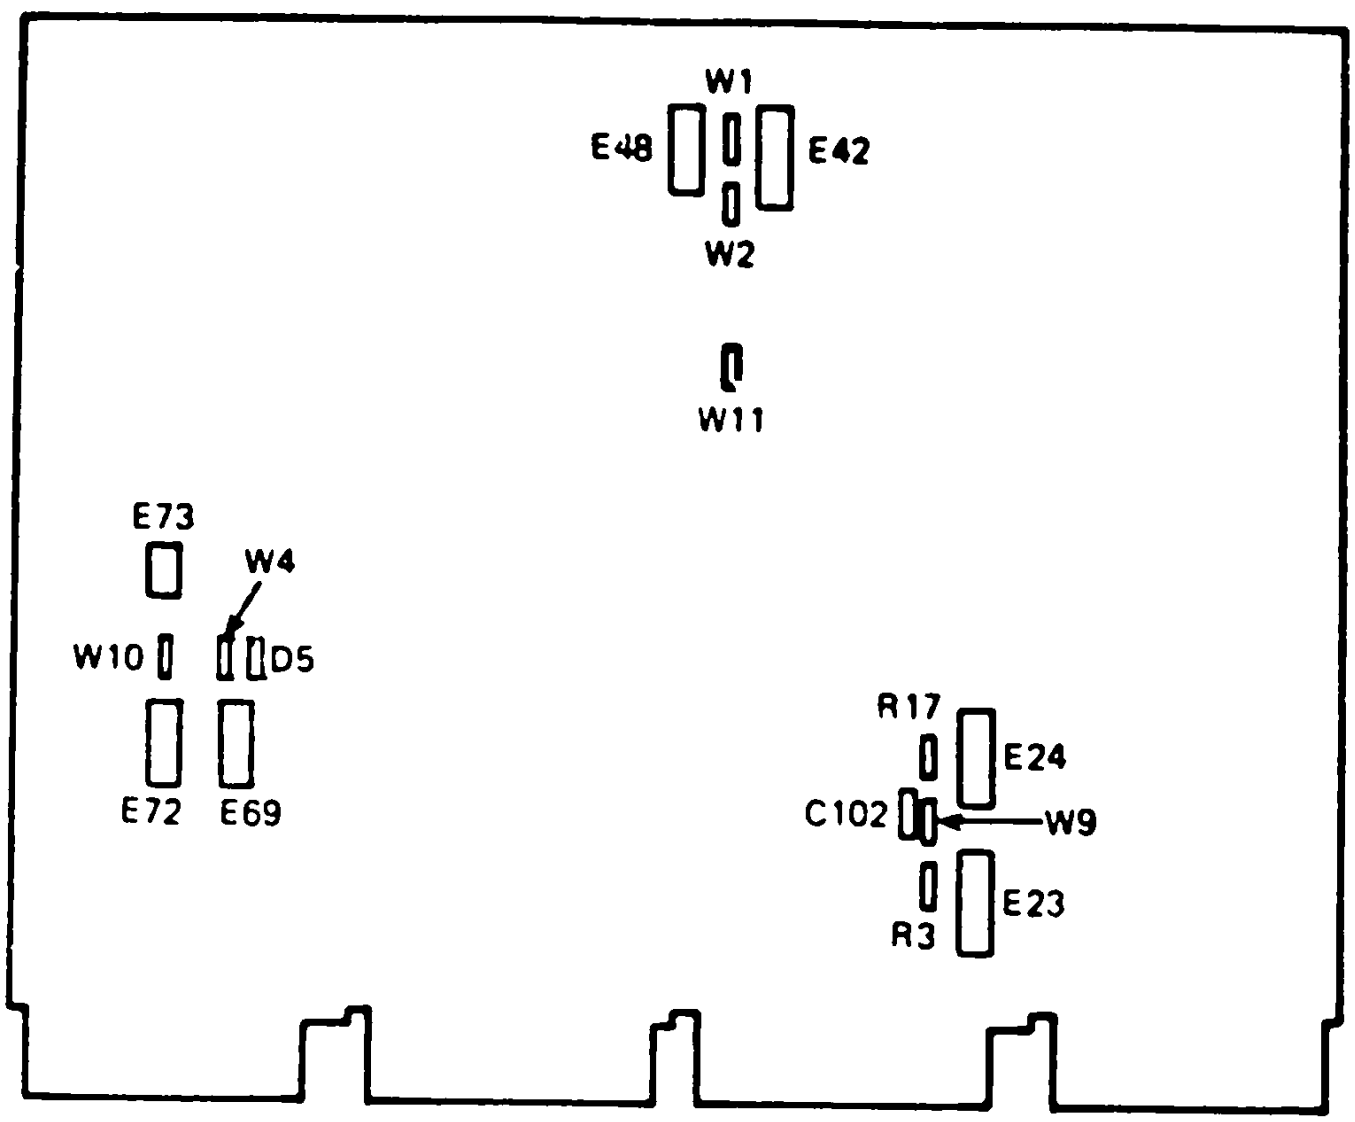
M7264 Jumper Locations

The problem is a failing IC on the M7264-YC (LSI). This IC is manufactured by Western Digital and has been out of production for some time now. The problem with the IC is that they have been sitting on a shelf for a long time and are having shelf-life failures. Western Digital is starting to manufacture these IC and should be relieve the problem.

The only work around for this problem at the present time is to order a new module (M7264-YC). Until the MRC has turned on the test procedure to verify that the module does not failure, there is no-way of knowing if the new module will fail the same way.

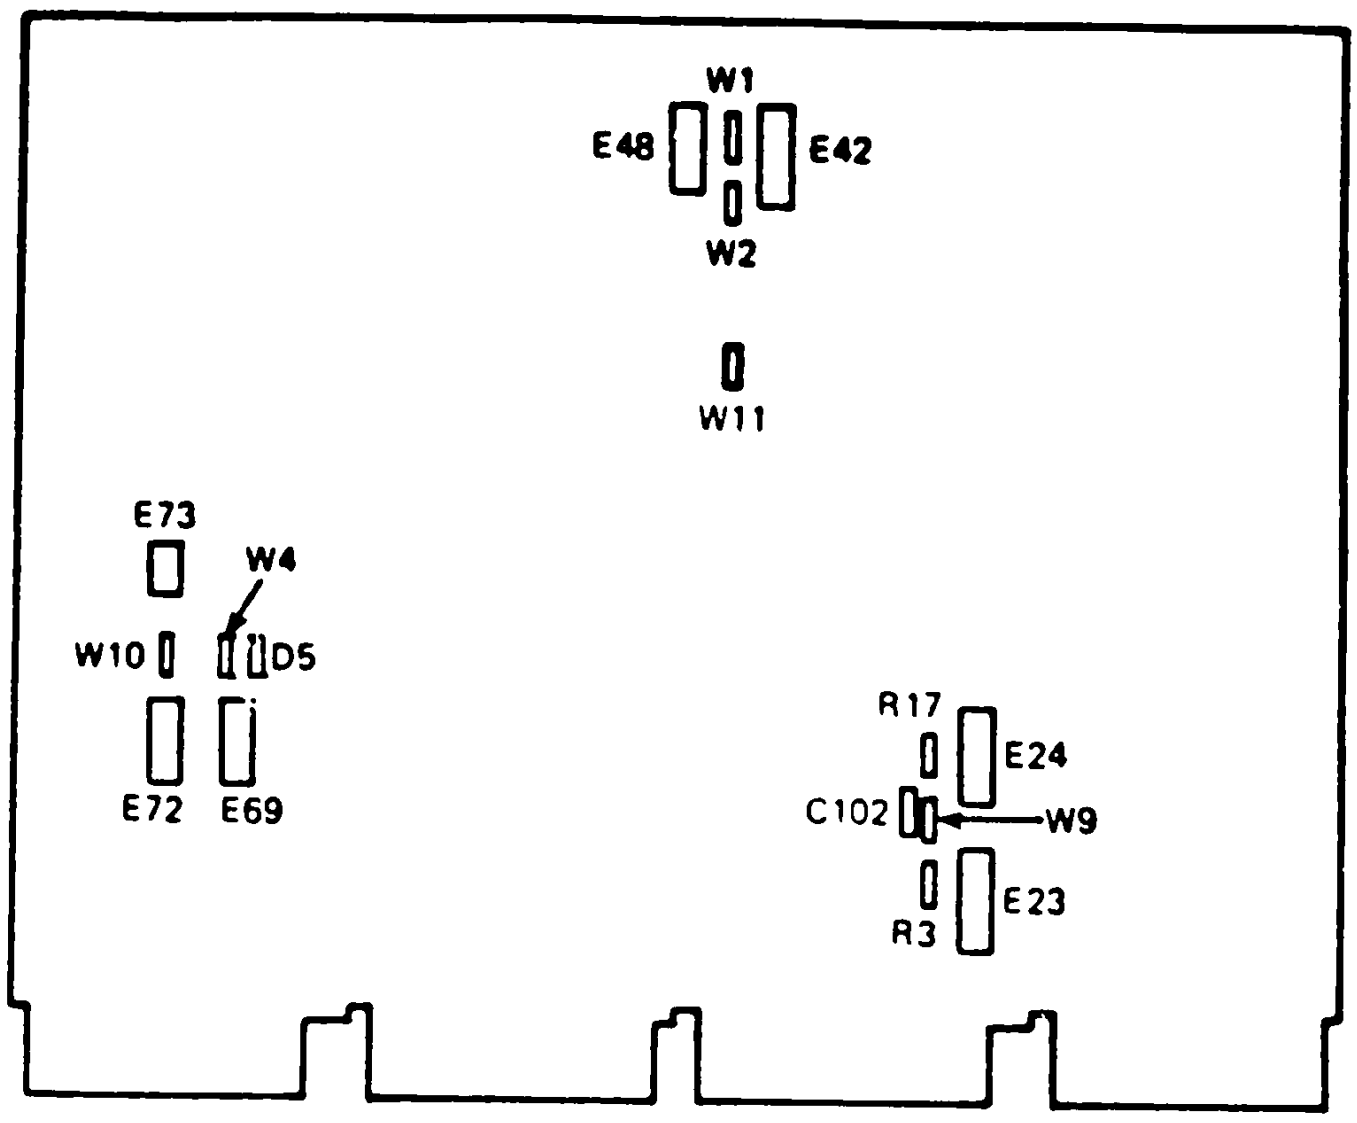
M7264 Jumper Locations

The problem is a failing IC on the M7264-YC (LSI). This IC is manufactured by Western Digital and has been out of production for some time now. The problem with the IC is that they have been sitting on a shelf for a long time and are having shelf-life failures. Western Digital is starting to manufacture these IC and should be relieve the problem.

The only work around for this problem at the present time is to order a new module (M7264-YC). Until the MRC has turned on the test procedure to verify that the module does not failure, there is no-way of knowing if the new module will fail the same way.

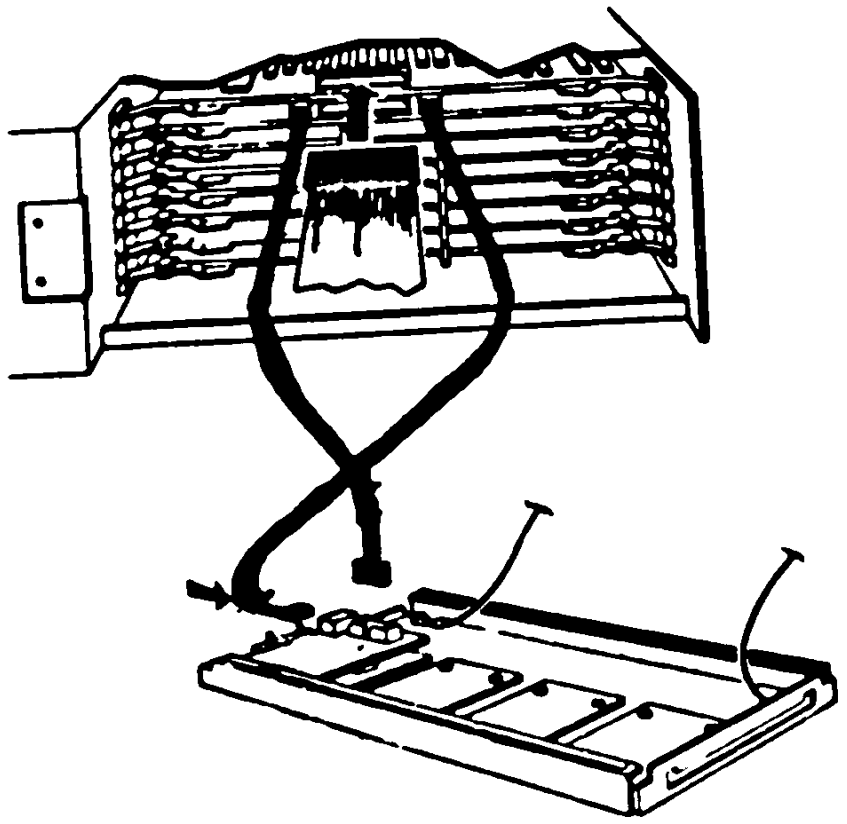
The documentation for the Micro-Vax I does not give a good indication of how the cables on the Data Path (DAP) board are connected to the Patch Panel. In fact, one of the illustrations in the Owners Manual makes it look cabled in wrong. Both ends of each cable are keyed and it is impossible to get the ends reversed at the patch panel end, but the ends are identical for the 2 connectors to the DAP board. For the correct cabling, see the illustration below and remember that the cables should be crossed.
